**Flood Control Project Maintenance
Levee Inspections**

Fall 2010 Levee Maintenance Deficiency Summary Report

Sacramento River Basin

Reclamation District No. 0785 Driver

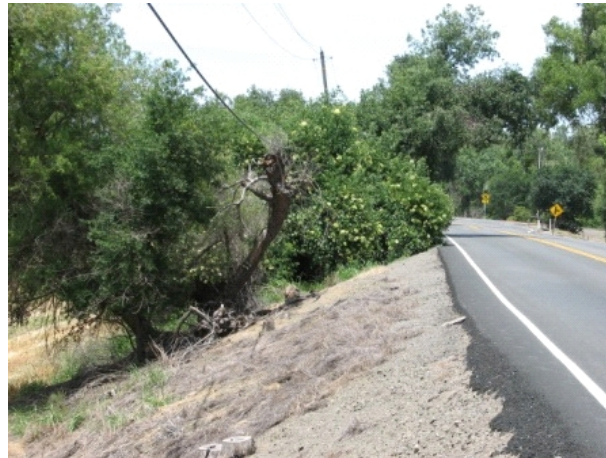
Levee Mile Report Line	1
Start Levee Mile	0.29
End Levee Mile	0.29
Location	Land Side
Category	Earthen Levee
Item	Vegetation

Waterway						Bank	Unit Miles	Inspection Start/End	Inspector	
Unit No. 01 Sacramento River						Right	2.31	11/18/2010 11/18/2010	John Williamson	
LMR No.	Levee Mile		Category	Item	* Location	** Rating	Action/Comment	GPS Latitude/Longitude		Issue No.
	Start	End						Start	End	Photo
1	0.29	0.29	Earthen Levee	Vegetation	LS	W	Elderberries are blocking visibility and flood fight capability.	38.658467 ° -121.609573 °	38.658467 ° -121.609573 °	1 Y
2	0.41	0.45	Earthen Levee	Vegetation	LS	W	Elderberries are blocking visibility and flood fight capability.	38.657168 ° -121.608270 °	38.656697 ° -121.607845 °	2 Y
3	0.85	0.94	Earthen Levee	Vegetation	LS	W	Elderberries are blocking visibility and flood fight capability.	38.651863 ° -121.604158 °	38.650777 ° -121.603182 °	5
4	1.32	1.32	Earthen Levee	Vegetation	LS	W	Elderberries are blocking visibility and flood fight capability.	38.646712 ° -121.599095 °	38.646712 ° -121.599095 °	6 Y

Elderberry

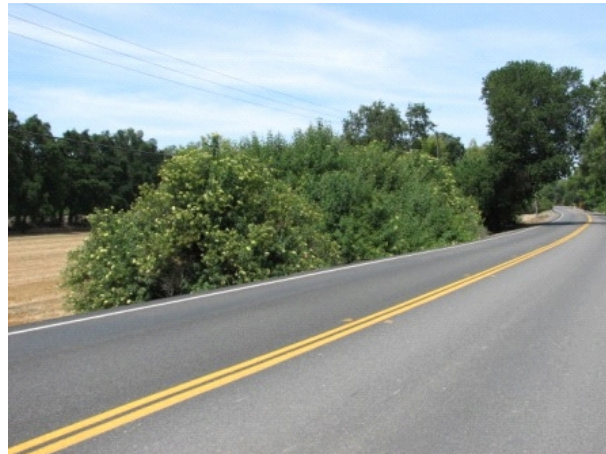
Levee Mile Report Line	2
Start Levee Mile	0.41
End Levee Mile	0.45
Location	Land Side
Category	Earthen Levee
Item	Vegetation

Elderberry

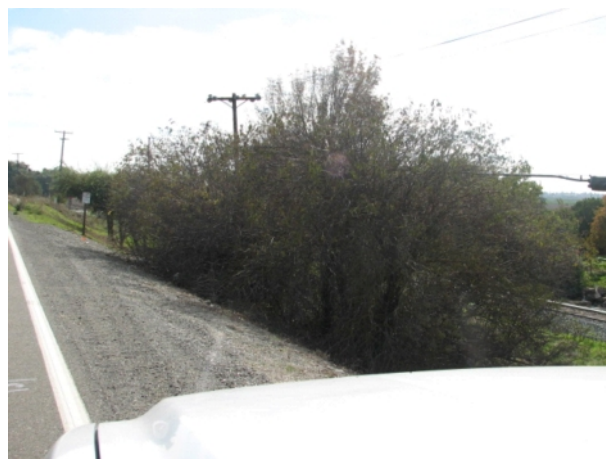
Levee Mile Report Line	4
Start Levee Mile	1.32
End Levee Mile	1.32
Location	Land Side
Category	Earthen Levee
Item	Vegetation

This is a very large Elderberry bush

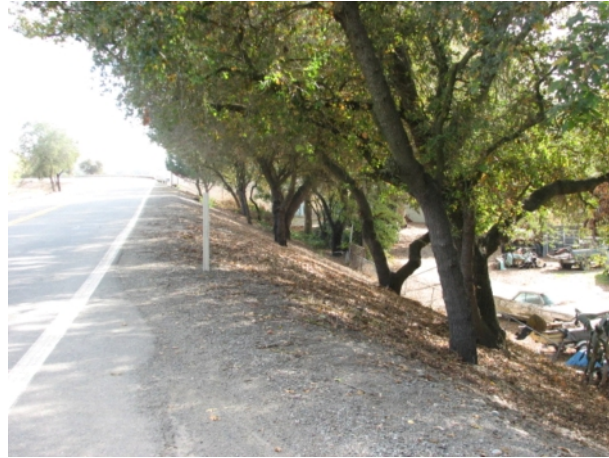
Levee Mile Report Line	5
Start Levee Mile	1.65
End Levee Mile	1.65
Location	Land Side
Category	Earthen Levee
Item	Trim / Thin Trees

The home owner has been working on raising the trees. There is still shrubs and stairs on the levee.

5	1.65	1.65	Earthen Levee	Trim / Thin Trees	LS	A	Trim trees to at least five feet above ground level. Inspector Comments: This is the Haskin Ranch.	38.643310 ° -121.595138 °	38.643310 ° -121.595138 °	4 Y
6	1.65	1.65	Earthen Levee	Encroachments	LS	PO	Landscaping Inspector Comments: Landscape shrubs and stairs are in place.	38.643310 ° -121.595140 °	38.643310 ° -121.595140 °	3
7	2.04	2.14	Earthen Levee	Encroachments	LS	PO	Landscaping Inspector Comments: pine trees need to be raised for 5' clearance	38.641623 ° -121.588558 °	38.642005 ° -121.586993 °	8 Y

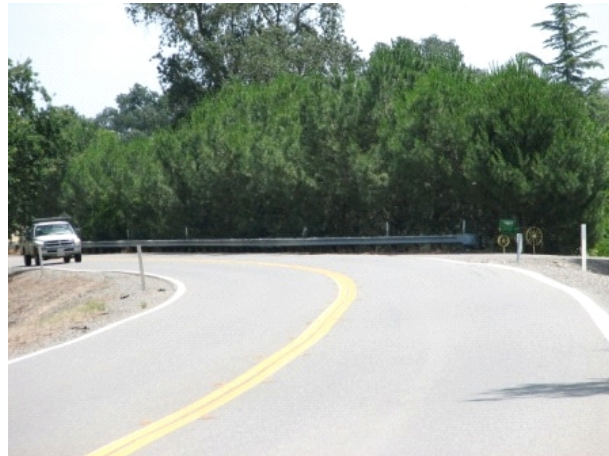
Levee Mile Report Line	7
Start Levee Mile	2.04
End Levee Mile	2.14
Location	Land Side
Category	Earthen Levee
Item	Encroachments

pinos and oleanders along shoulder

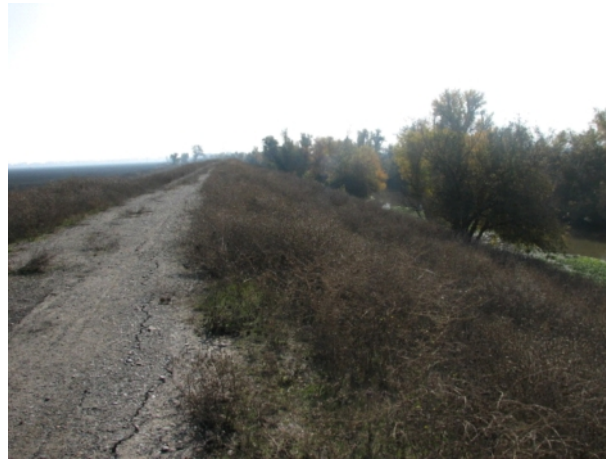
Levee Mile Report Line	1
Start Levee Mile	0.63
End Levee Mile	3.28
Location	Water Side
Category	Earthen Levee
Item	Vegetation

Photo is of the waterside levee slope with star thistle.

Waterway							Bank	Unit Miles	Inspection Start/End	Inspector
Unit No. 02 Yolo Bypass							Left	3.30	11/16/2010 11/16/2010	John Williamson
LMR No.	Levee Mile		Category	Item	Location	Rating	Action/Comment	GPS Latitude/Longitude		Issue No.
	Start	End						Start	End	Photo
1	0.63	3.28	Earthen Levee	Vegetation	WS	M	Remove the wild growth other than native grasses from the levee slopes.	38.632718 ° -121.615321 °	38.599633 ° -121.590408 °	2 Y
2	0.63	3.28	Earthen Levee	Vegetation	LS	M	Remove the wild growth other than native grasses from the levee slopes.	38.632718 ° -121.615321 °	38.599634 ° -121.590408 °	1 Y
3	0.66	3.25	Earthen Levee	Crown Surface / Depressions / Rutting	CR	M	Keep the crown roadway free of vegetation.	38.632402 ° -121.615109 °	38.600047 ° -121.590769 °	3
4	0.83	0.83	Earthen Levee	Crown Surface / Depressions / Rutting	CR	M	Add appropriate gravel or road base. Grade and compact.	38.630157 ° -121.613842 °	38.630157 ° -121.613842 °	10

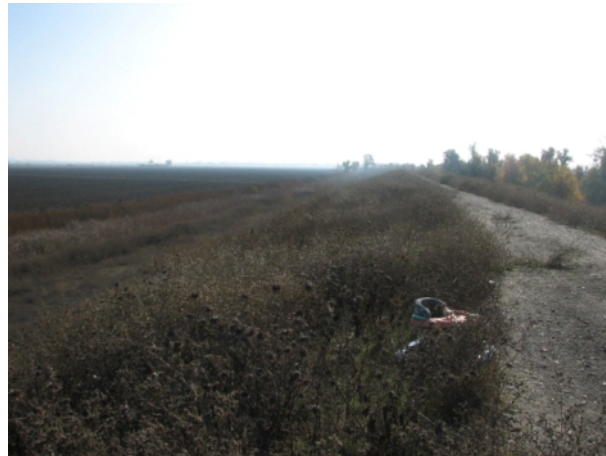
Levee Mile Report Line	2
Start Levee Mile	0.63
End Levee Mile	3.28
Location	Land Side
Category	Earthen Levee
Item	Vegetation

Photo is of landside levee slope with star thistle.
